Project NY 013 02A-5  
Final Technical Memorandum M-062

EVALUATION OF AN EXPERIMENTAL TOBOGGAN

13 July 1953

U.S. Naval Civil Engineering Research and Evaluation Laboratory,  
Port Hueneme, California

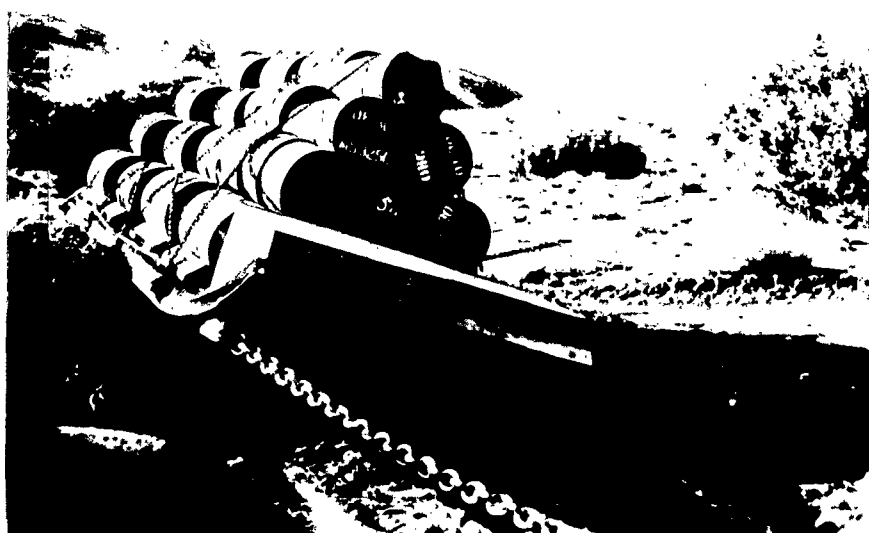
Figure 2. Toboggan being subjected to racking action at Rose Valley Test Site on hard, uneven terrain, the load secured by chains and chain binders.

Upon completion of the tests in sandy terrain, the toboggan was unloaded and moved to the Rose Valley Test Site. There it was reloaded with forty 55-gal. drums, filled with water and arranged in four rows, ten drums pyramided in each row. The load was secured to the toboggan by means of chains and chain binders, as shown in Fig. 2. The toboggan was towed by a D-8 Caterpillar tractor over a trail that included rolling, uneven terrain; thick mesquite; and steep banks as high as 12 ft. Towing tests were continued for a total of 16 hours under these conditions.

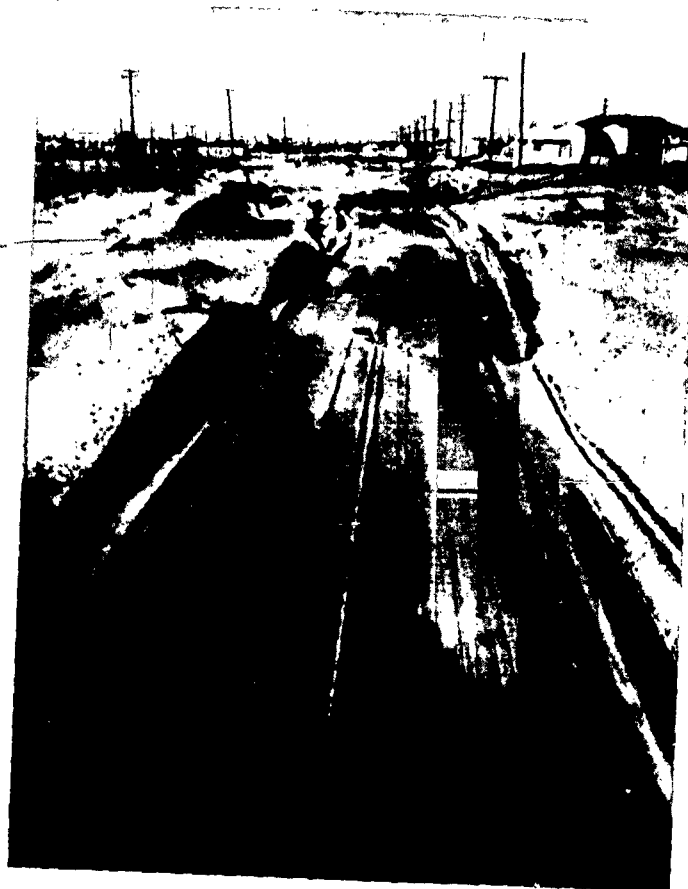
Figure 3. Uneven soft sand terrain leveled by the weight of the towed toboggan.

When towed over a side hill and up a 4-ft high bank with a 2-1/2 to 1 slope, the toboggan did not appear to deform. The toboggan was heavy enough to level rough terrain and the tops of banks in loose sand (Fig. 3).

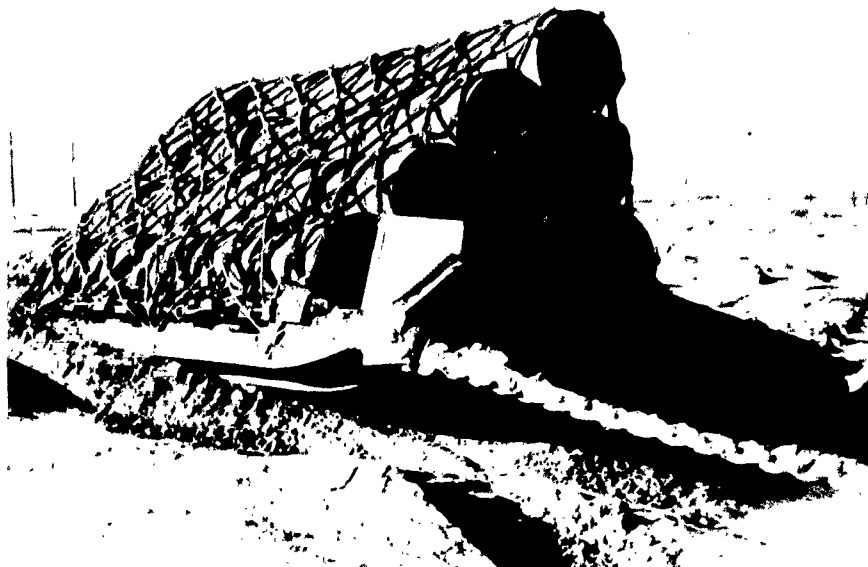
Figure 5. Toboggan being pulled over the edge of a berm in sandy soil. The toboggan did not distort, and the load did not shift.

No deformation of the toboggan was noted when it was towed over the edge of a bank or along the side of a berm, even though at times the toboggan was supported only on the sides or on the front and rear (Fig. 5). With the D-8 tractor, the toboggan was towed backward a distance of 45-ft, during which time the sand was piled ~~2 ft~~ above the toboggan bed.

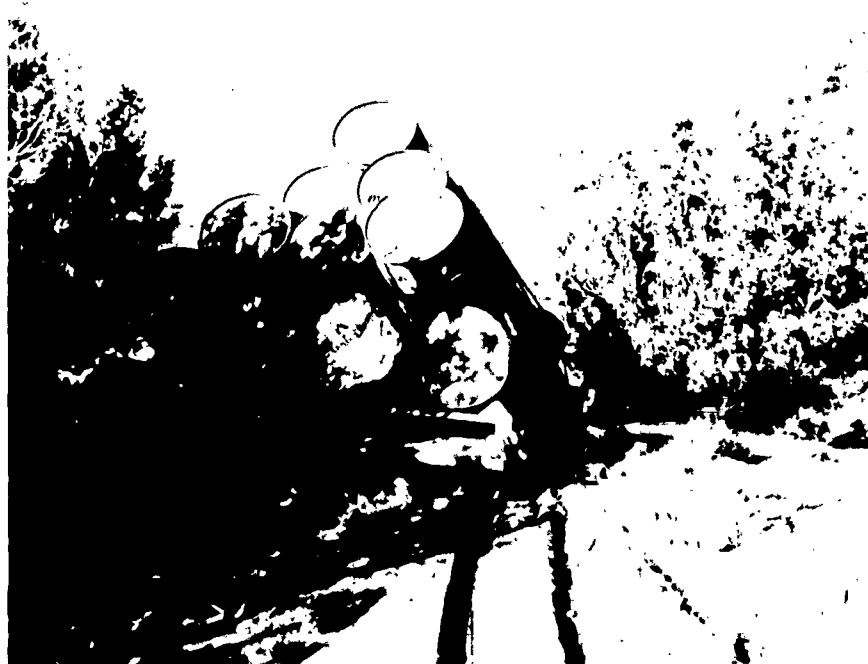
Figure 6. Shifting of load secured with chain rigging during trail tests at Rose Valley.

These trial tests demonstrated that the load was not securely held by the chains and chain binders (see Fig. 6). The pitching motion of the toboggan on hard, uneven terrain caused the drums to shift, making it necessary to stop the test and rearrange the load.

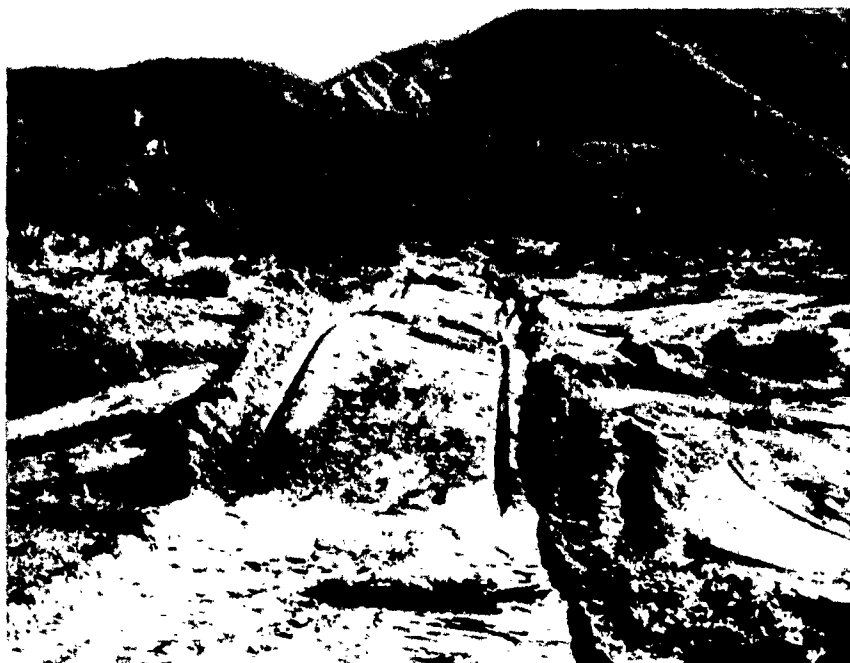
Figure 7. Toboggan tracks in hard, uneven terrain at Rose Valley Test Site.

The toboggan, riding on the runners on the hard surface at Rose Valley, it tracked well but again was difficult to maneuver (see Fig. 7).
